# SERVICE BULLETIN

TR-9000

#849

SUBJECT: TR-9000 Transmitter Sideband Carrier Balance

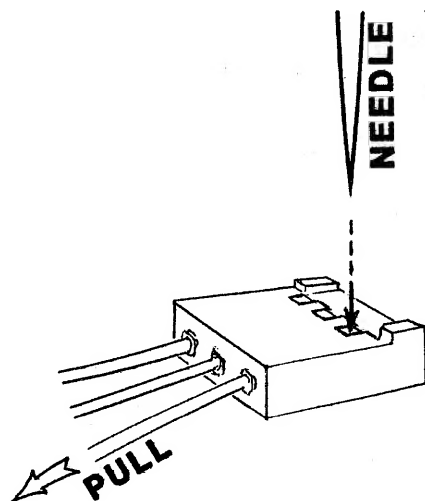
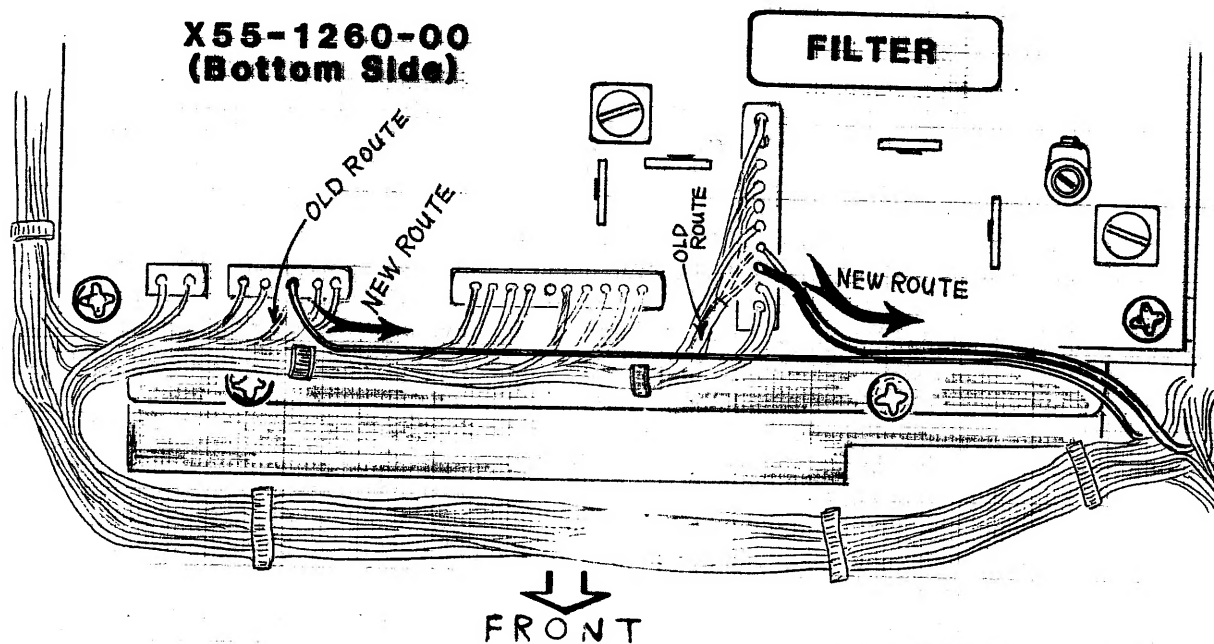
Distorted sideband transmission may have one of two causes. If normal alignment does not cure the problem, distortion or poor carrier suppression may be improved by rerouting two leads in the wire harness.

4. Carefully unplug each of these connectors by gripping the connector housing with a long-nosed plier.
5. Extract the terminal from the housing by depressing the locking tab and simultaneously withdrawing the lead with terminal. (see illustration on page 2).

6. Reroute these two lines from the behind the Mode switch, between the chassis and control unit, then left to their original connectors. Reinstall the terminals in their original positions in the connector housing.
